Fine sediment offset plan for Gladstone Ports Corporation

October 2023

This report has been prepared by Fitzroy Basin Association Ltd (FBA) and Alluvium Consulting Australia Pty Ltd for Gladstone Ports Corporation.

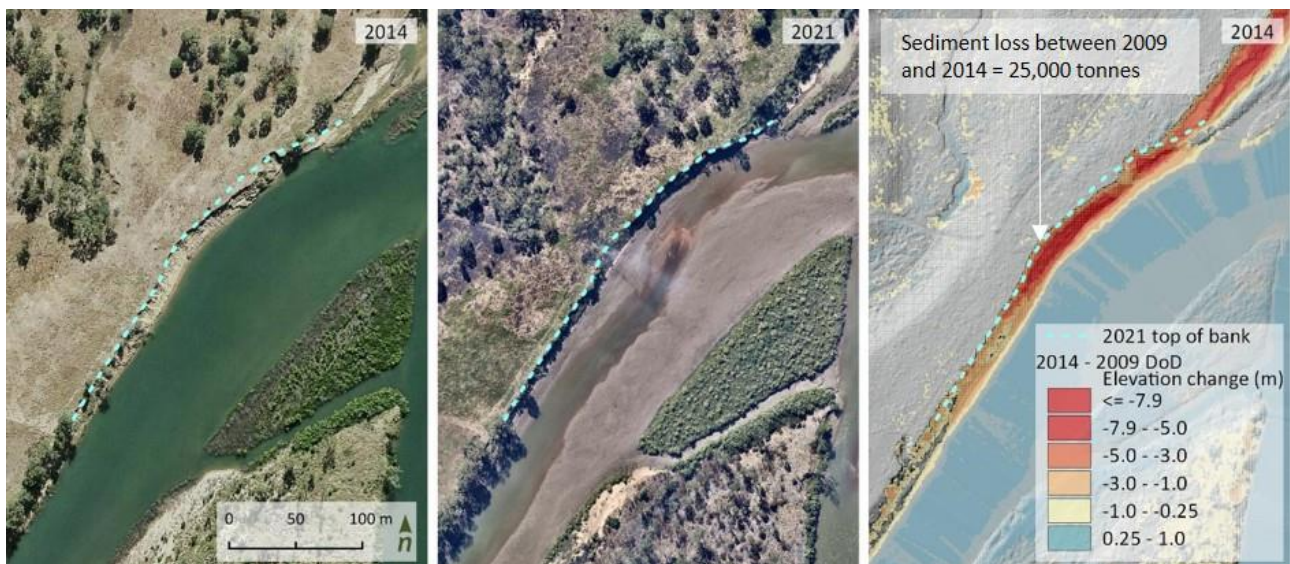
Figure 5. Multi-temporal imagery and LiDAR analysis example on the Calliope River approximately 10 km upstream of Gladstone

An example of combined historical aerial imagery and LiDAR analysis from Calliope River catchment, Boyne River catchment and Fitzroy River catchment is provided in Figure 5, Figure 6 and Figure 7 respectively.

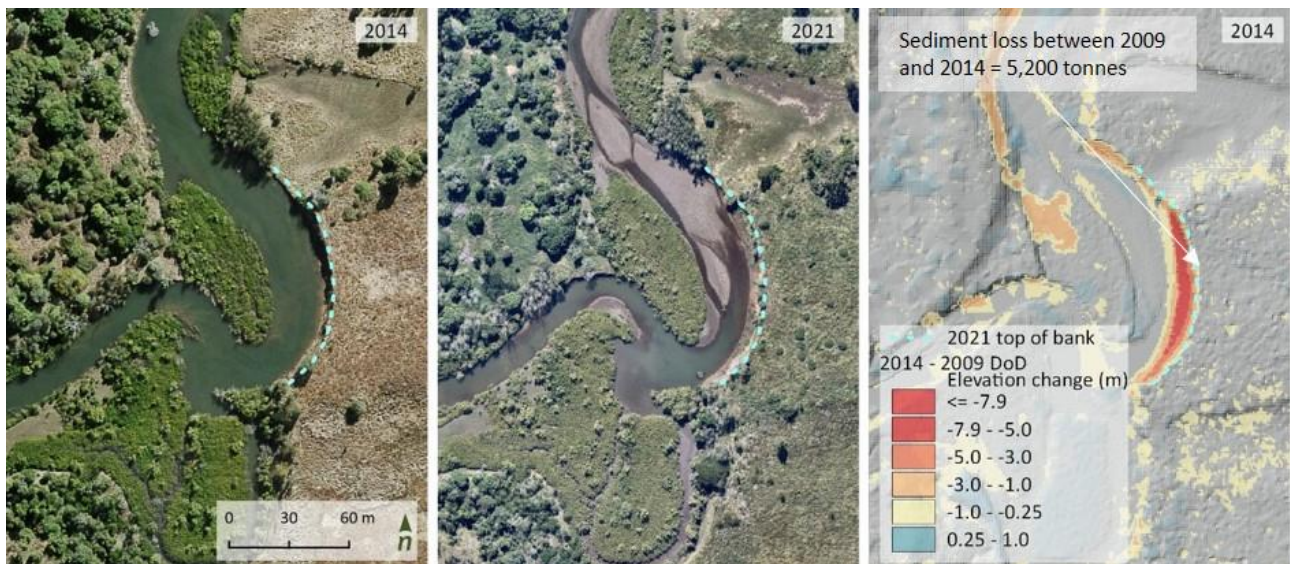
Figure 6. Multi-temporal imagery and LiDAR analysis example on a Boyne River tributary in Benaraby approximately 10 km upstream of ocean outlet at Tannum Sands

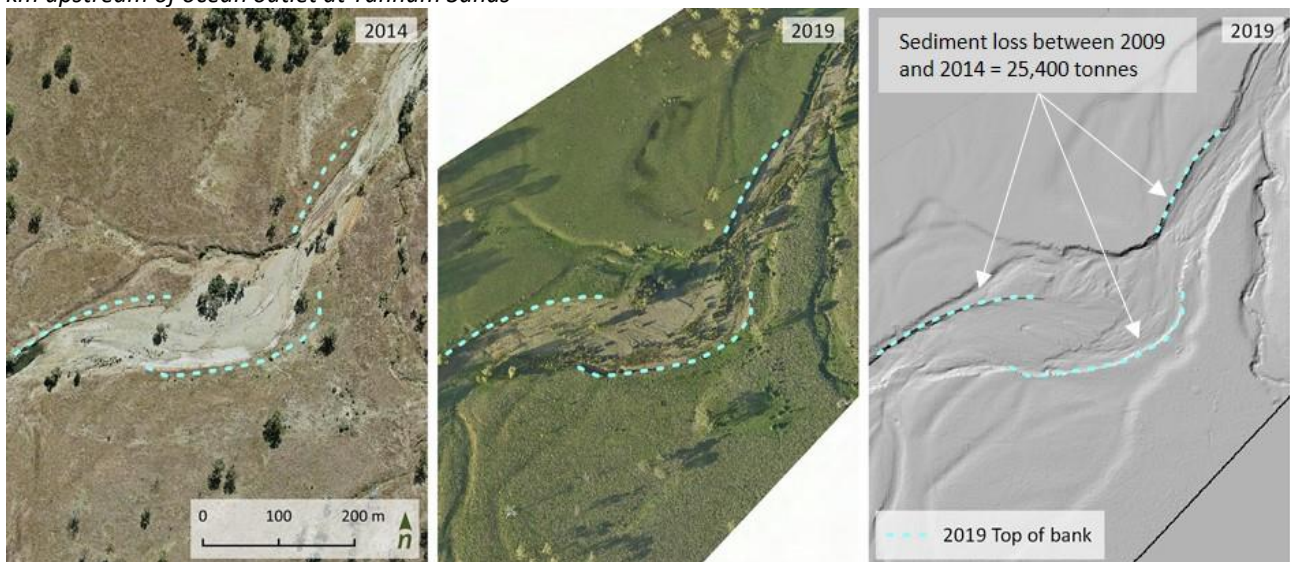
Figure 7. Multi-temporal imagery and LiDAR analysis example on Six Mile Creek, (Fitzroy River catchment) approximately 70 km upstream of ocean outlet

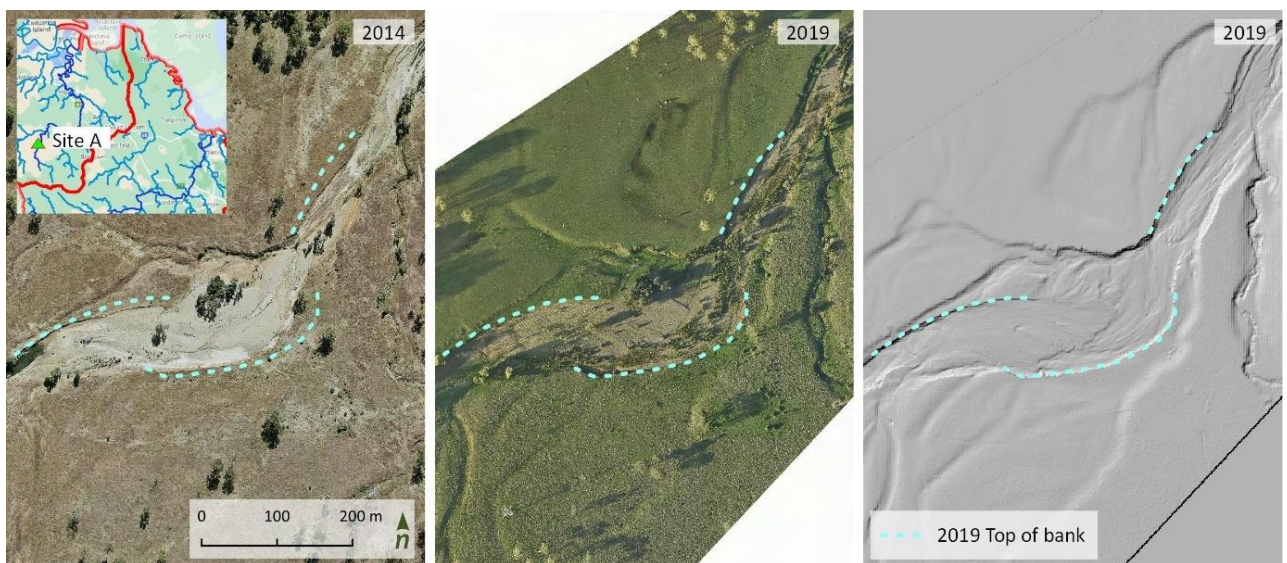
Figure 9. Multi-temporal analysis at Site A - Six Mile Creek - Streambank erosion (meander migration)

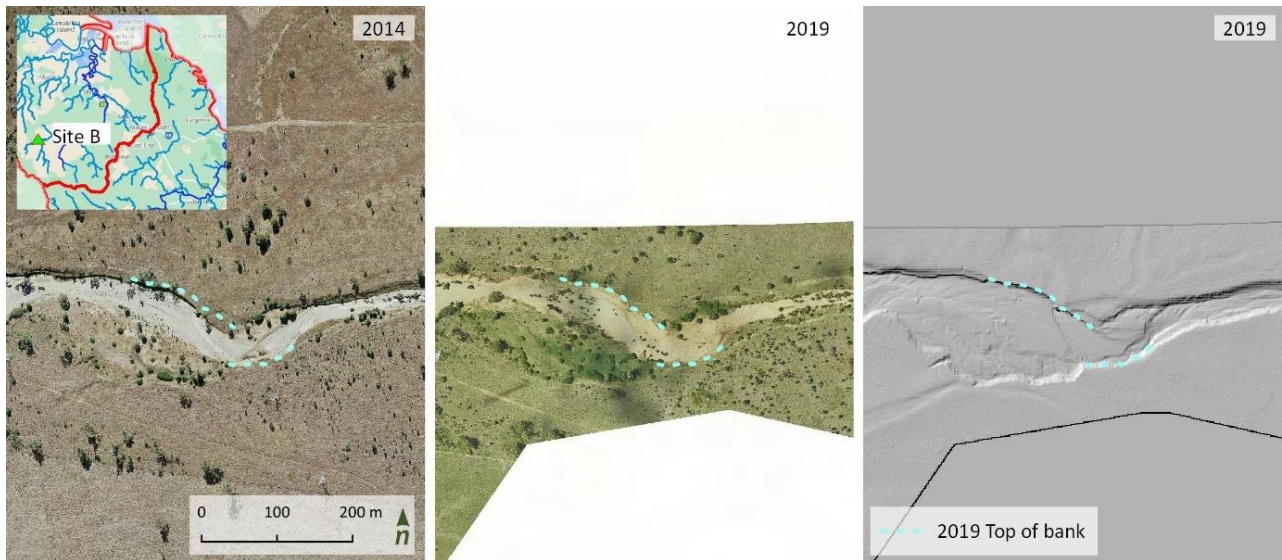
Figure 10. Multi-temporal analysis at Site B - Langmorn Creek - Streambank erosion (meander migration)

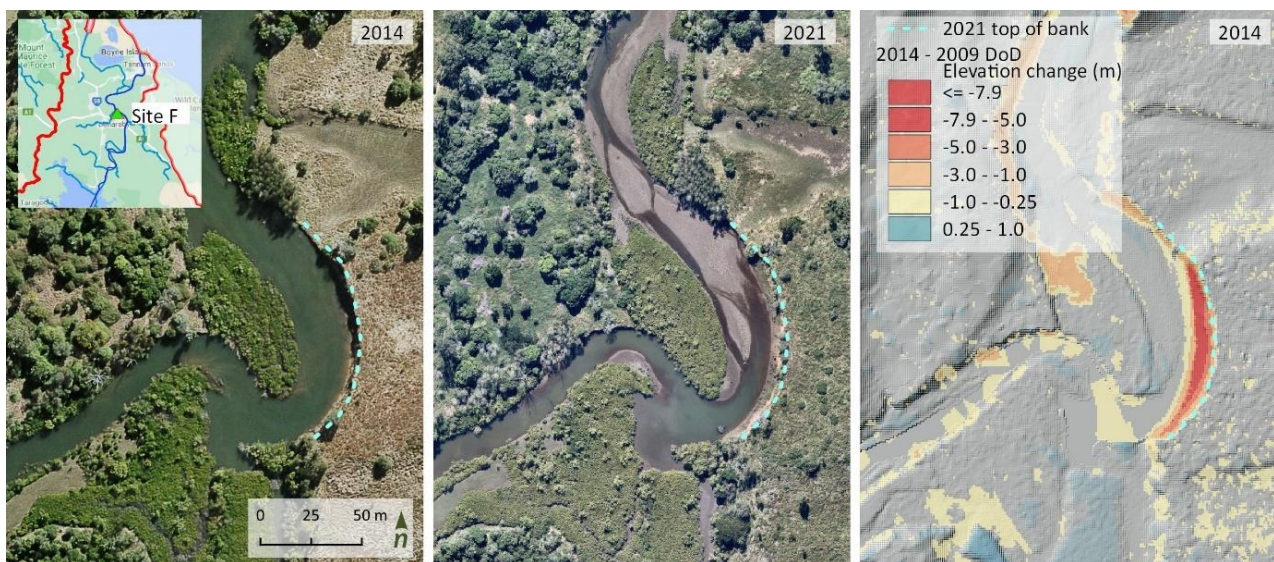
Figure 14. Multi-temporal analysis at Site F - Machine Creek - Streambank erosion (meander migration)

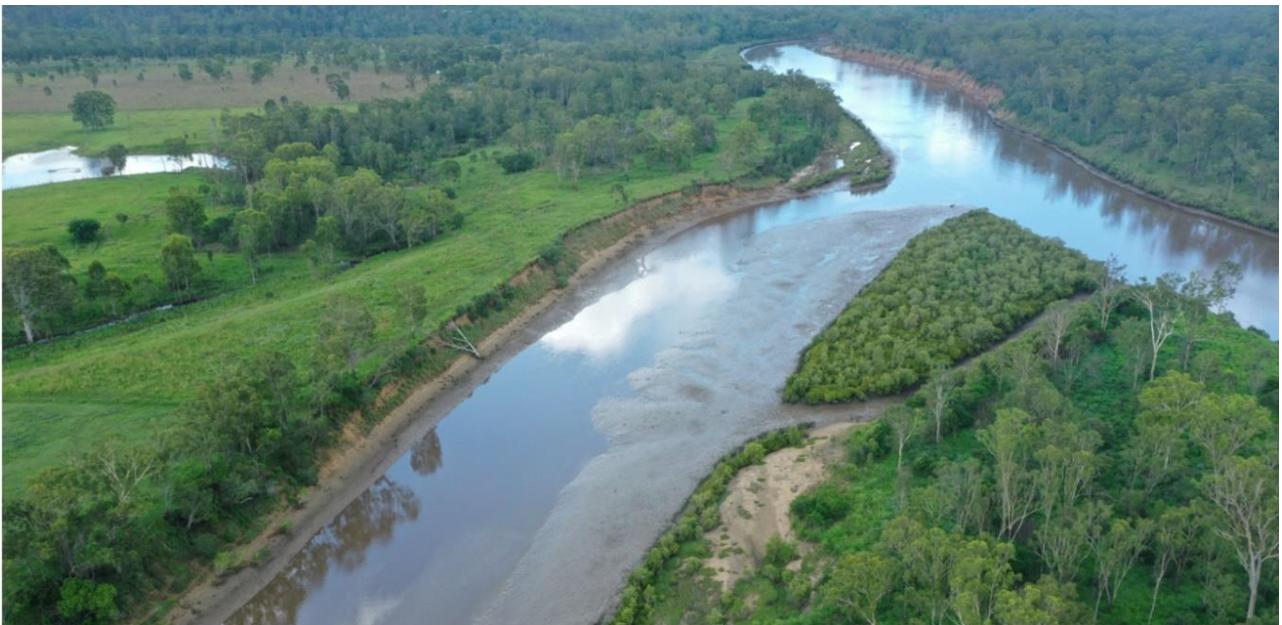
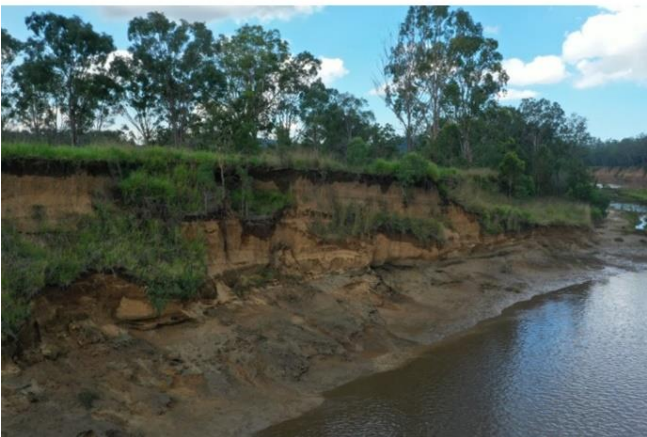
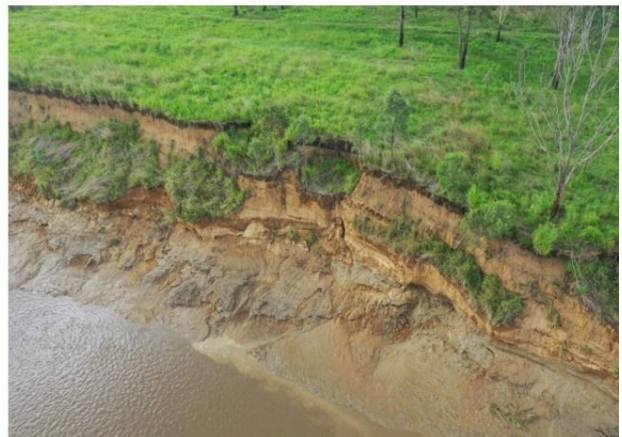
Figure 16. *Eroding section of bank at Site D - Calliope River (Photos taken December 2021)*

- Vertical to near vertical banks, undercut in some sections
- The banks are comprised of exposed alluvial sands, of loose to medium density, and clays of soft to firm consistency
- Several trees at the top of bank with exposed roots are likely to fall in the near future which could instigate further bank failure
- Erosion likely a result of a combination of fluvial scour and geotechnical failure
- Accelerated rates of bank retreat are occurring due to loss of deep-rooted floodplain vegetation which provides root reinforcement of the bank which is able to resist mass failure of bank material
- Wave action due to boat wash results in entrainment of bank sediments and limits vegetation recruitment

- Intertidal bench approximately 5 - 10 m wide has formed and mangroves are beginning to establish at the toe of bank
- Upstream of site has significant colonisation of mature mangroves along the bank toe
- Access to site requires crossing a small creek and water storage overflow, would require some works to provide appropriate access for machinery
- Sandy nature of bank material may require a gentle batter to achieve appropriate slope stability (1V:4H) resulting in significant volume of spoil to be removed
- Limited areas for onsite spoil disposal
- Land manager happy to exclude stock from site during vegetation establishment period. Cattle to be allowed back into the site for short periods to control grass growth and reduce fire risk as necessary after the vegetation establishment period.

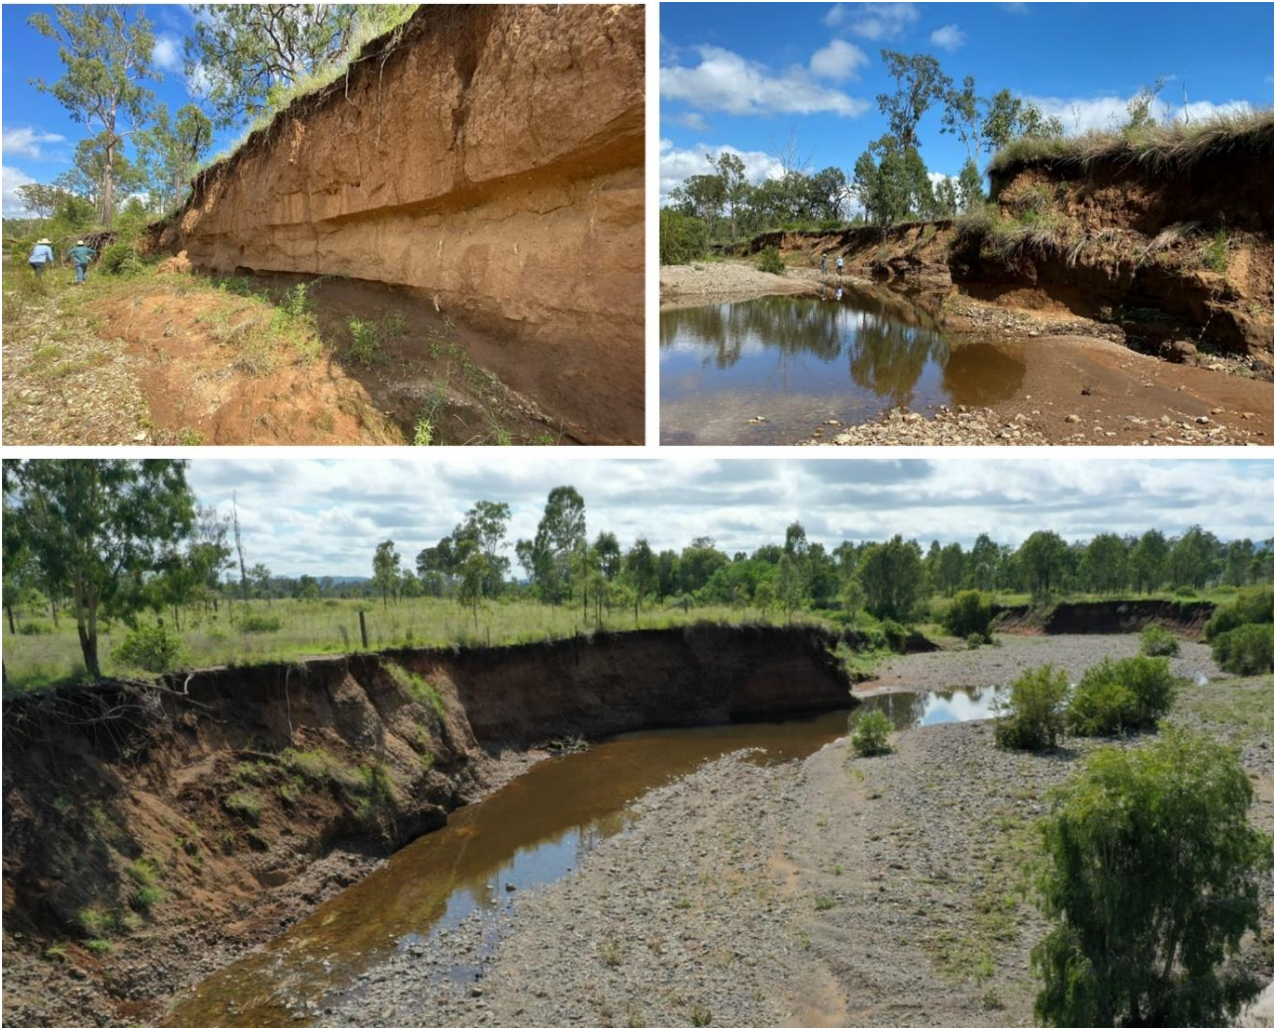
Figure 18. Exposed eroding banks at Site B on Langmorn Creek (Photos taken December 2021)

- Vertical to near vertical banks, undercut in some sections
- Bed material largely cobbles gravels and sands
- High variability in bank substrate including sands, sandy clays, clay loams and sandy silty clays
- Presence of a gravel lens at the toe of bank and sections of interspersed gravels through the bank profile
- Several trees at the top of bank with exposed roots, likely to be felled in near future which could instigate further bank failure
- Dominant erosional process is meander migration resulting in erosion of floodplain units
- Erosion likely a result of a combination of fluvial scour and geotechnical failure of undercut banks

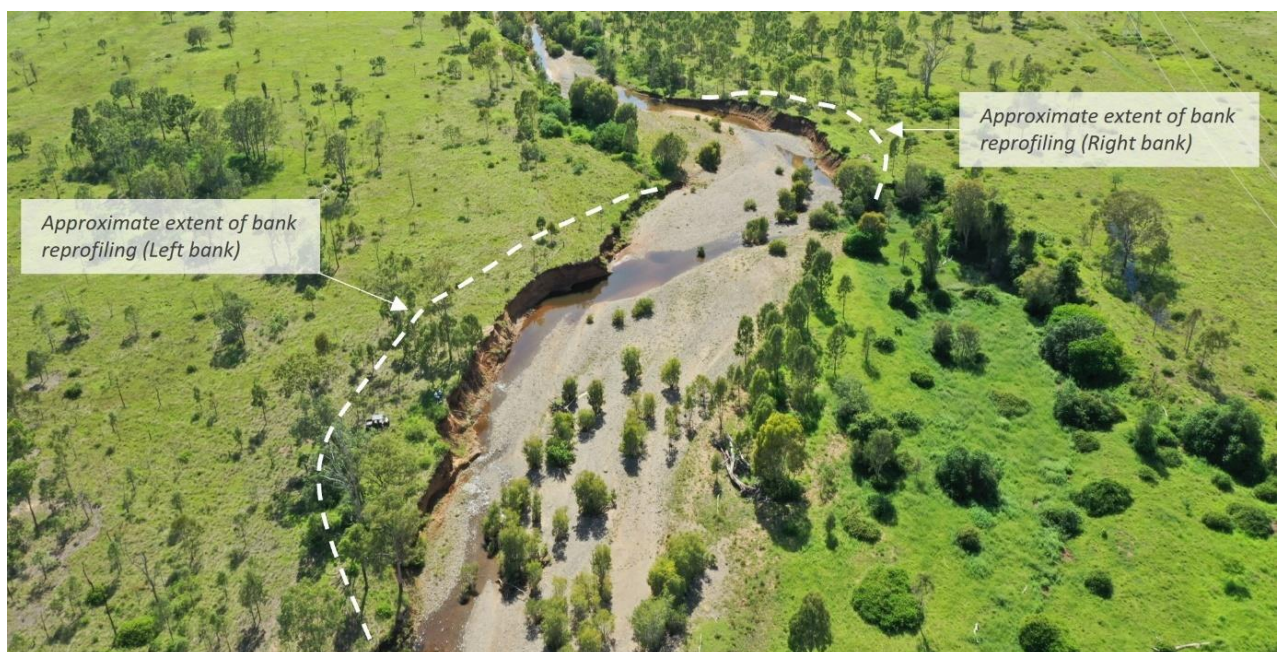
Figure 23. Approximate extent of proposed bank reprofiling works

Bank reprofiling works are to be undertaken where the existing bank slope is near vertical, exposed and actively eroding. On the left bank, the length of bank reprofiling required is approximately 170 m and approximately 110 m on the right bank (Figure 23). The reprofiled bank has been designed at a slope of 1V:3H which is likely to achieve slope stability and allow the establishment of native vegetation.

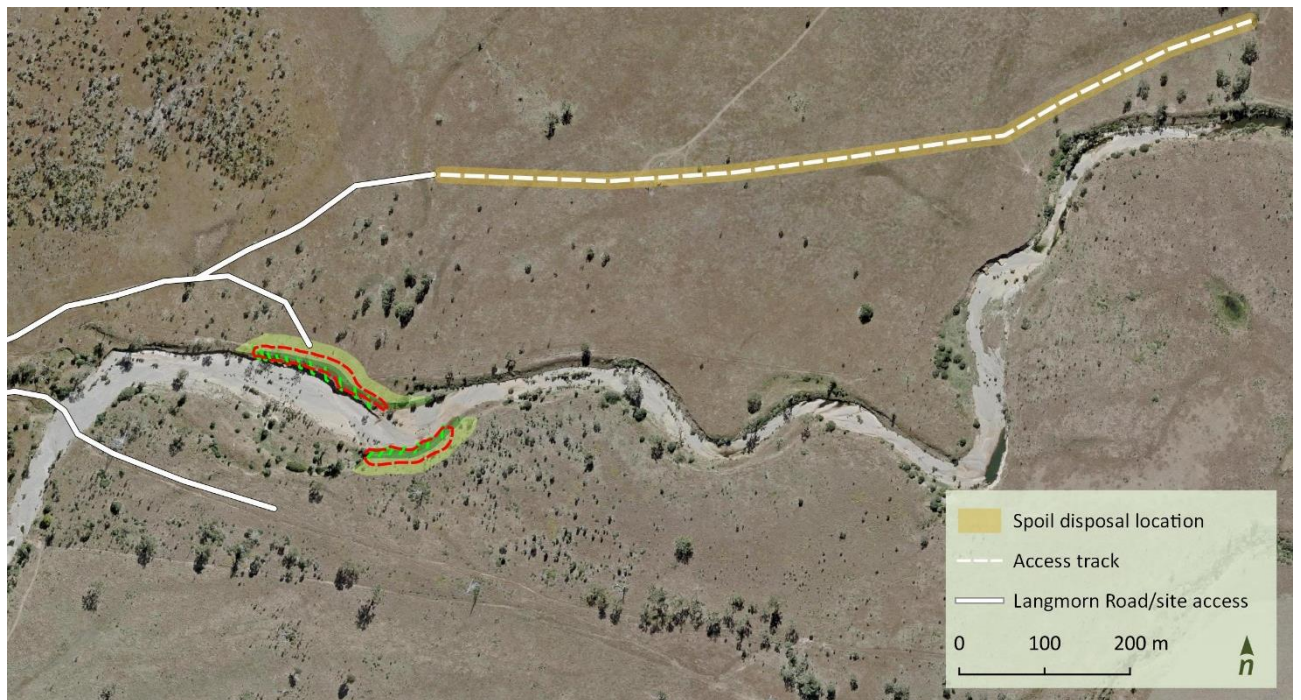
Figure 24. Spoil disposal location

An example of a typical reprofiling cross section is presented in Figure 25. It is estimated that a total of 6,760 m³ of material will be produced as a result of the earthworks from both banks. A suitable location for the disposal of this material has been identified in consultation with the land manager. The spoil is to be placed in a depression either side of an access track that runs east-west approximately 200 m north of the site. The disposal area is approximately 980 m in length and fill will be spread approximately 10 m either side of the track at a depth of approximately 0.3 m (see Figure 24). The existing vegetation in this location is limited to isolated trees that will not be disturbed by the spreading of material. The spoil zone will then be grassed. Extensive desktop and field surveys have been completed on site to assess any potential impacts to threatened species and Matters of National Significance (MNES). Whilst squatter pigeons were a potential concern from desktop analysis, field surveys showed no squatter pigeons resided within the project impact area. Further details of these surveys can be found in section 4.6.

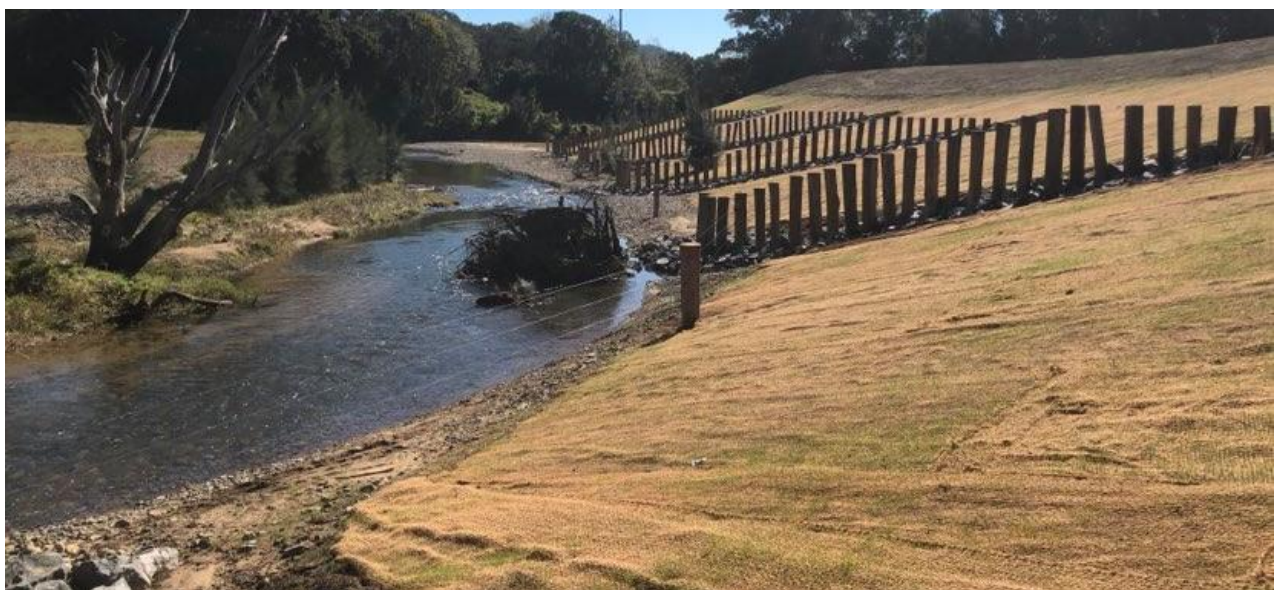
Figure 26. Example of coir mesh installation on the Mary River

The earthworks will ensure drainage from the local catchment is not conveyed across the reprofiled bank. This may require small earth bunds to redirect runoff to the river away from the proposed works (i.e. downstream of the works). No ponding of water is allowed within 15 m of the top of the reprofiled bank. Once topsoil is laid, erosion matting such as coir mesh or equivalent will be installed to the manufacturer specifications prior to revegetation works (example shown in Figure 26) to further reduce risk of short-term erosion.

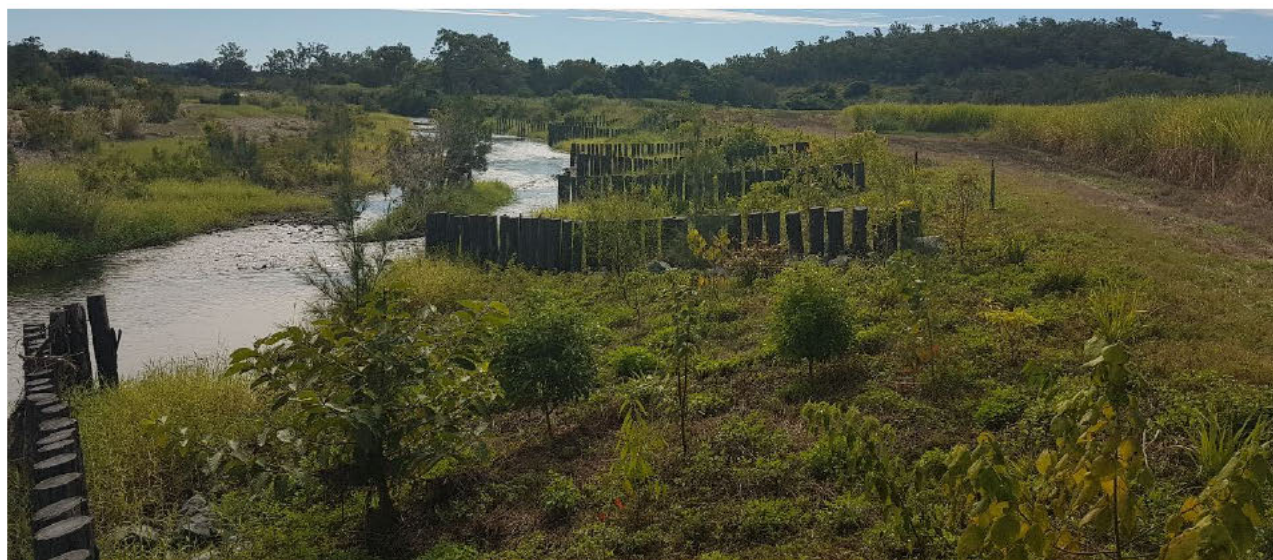
Figure 27. Example of pile field groynes protecting revegetation works

Pile field toe protection will assist in reducing the likelihood of scour along the lower bank and provide protection to the vegetation establishment along the lower bank. The pile fields will reduce shear stress in the lower bank zone which will promote sediment deposition and provide favourable condition for vegetation establishment (Figure 27).

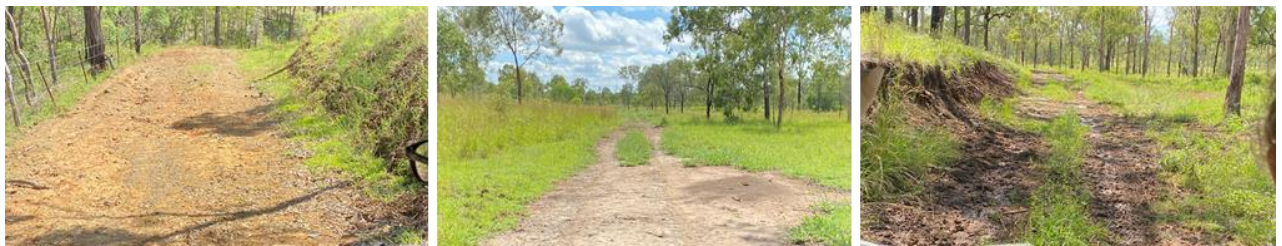
Figure 32. Photos showing the condition of the existing access track to the site from Langmorn Road

are presented in Figure 32). The access track is suitable for access of all the required equipment in and out of the site with some minor maintenance work to be undertaken including:

- Light grading for daily use during construction
- Line the main hill (highlighted in blue) with fresh gravel to reduce risk of light vehicles getting stuck if heavy rain occurs
- Installation of 'Whoa-boys' on the main hill at completion of project to divert road runoff to stable location

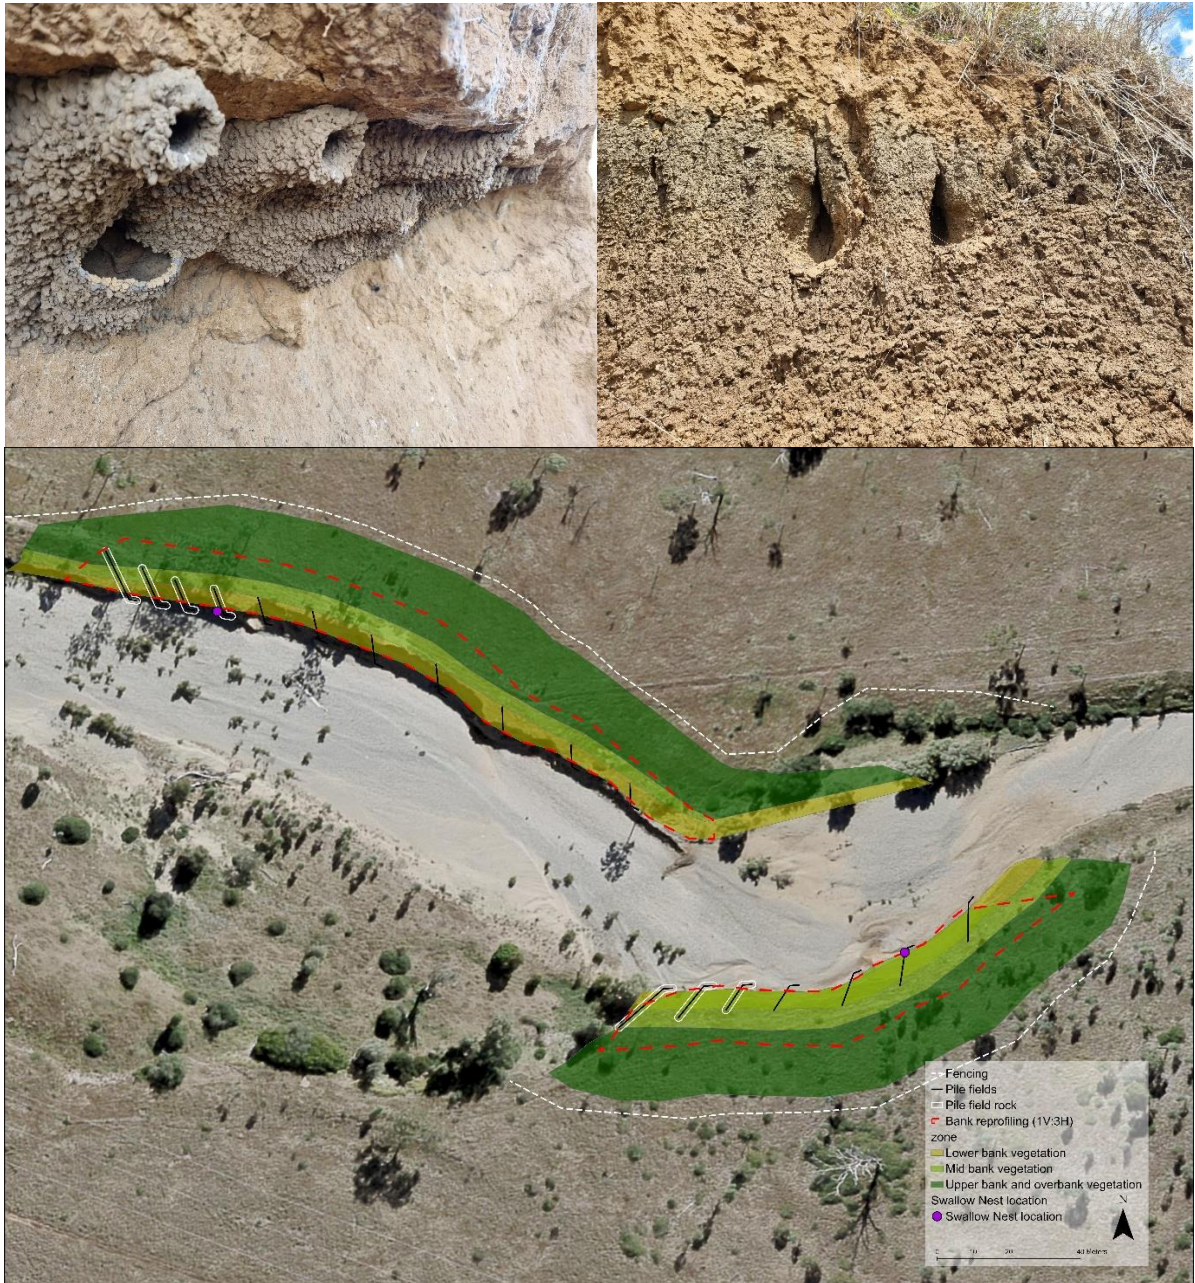
Figure 33: Location and Images of Welcome Swallow *Hirundo neoxena* nests taken during fauna surveys completed on the 15th (top left) and 29th (top right) of September. Mud structures were found on the northern bank with large undercutting bank walls predicted to collapse with the next high rainfall event. Nests dug into the side of the southern bank were not present at the beginning of fauna surveys but appeared within the week between the fifth and final survey.

No Squatter Pigeons were identified as present on the project site and all other species were listed as Least Concern. Welcome Swallows *Hirundo neoxena* listed as Marine were found within the site and their nests found within the bank of the eroding riverbank wall in two sections on the construction site (Figure 33). Due to this species being listed as Special Least concern and a colonial breeder, specific actions (outlined in Table 7) will need to be implemented to ensure as minimal as possible disturbance to the species and/or safe relocation of active nests. The location and position of the nests on an undercut of the bank wall suggests that if remediation activities did not occur these nests would likely be lost during the next high rainfall event. It is therefore highly likely that the nests may no longer be present on the riverbank when construction activities are to take place. No other MNES were identified during field surveys.

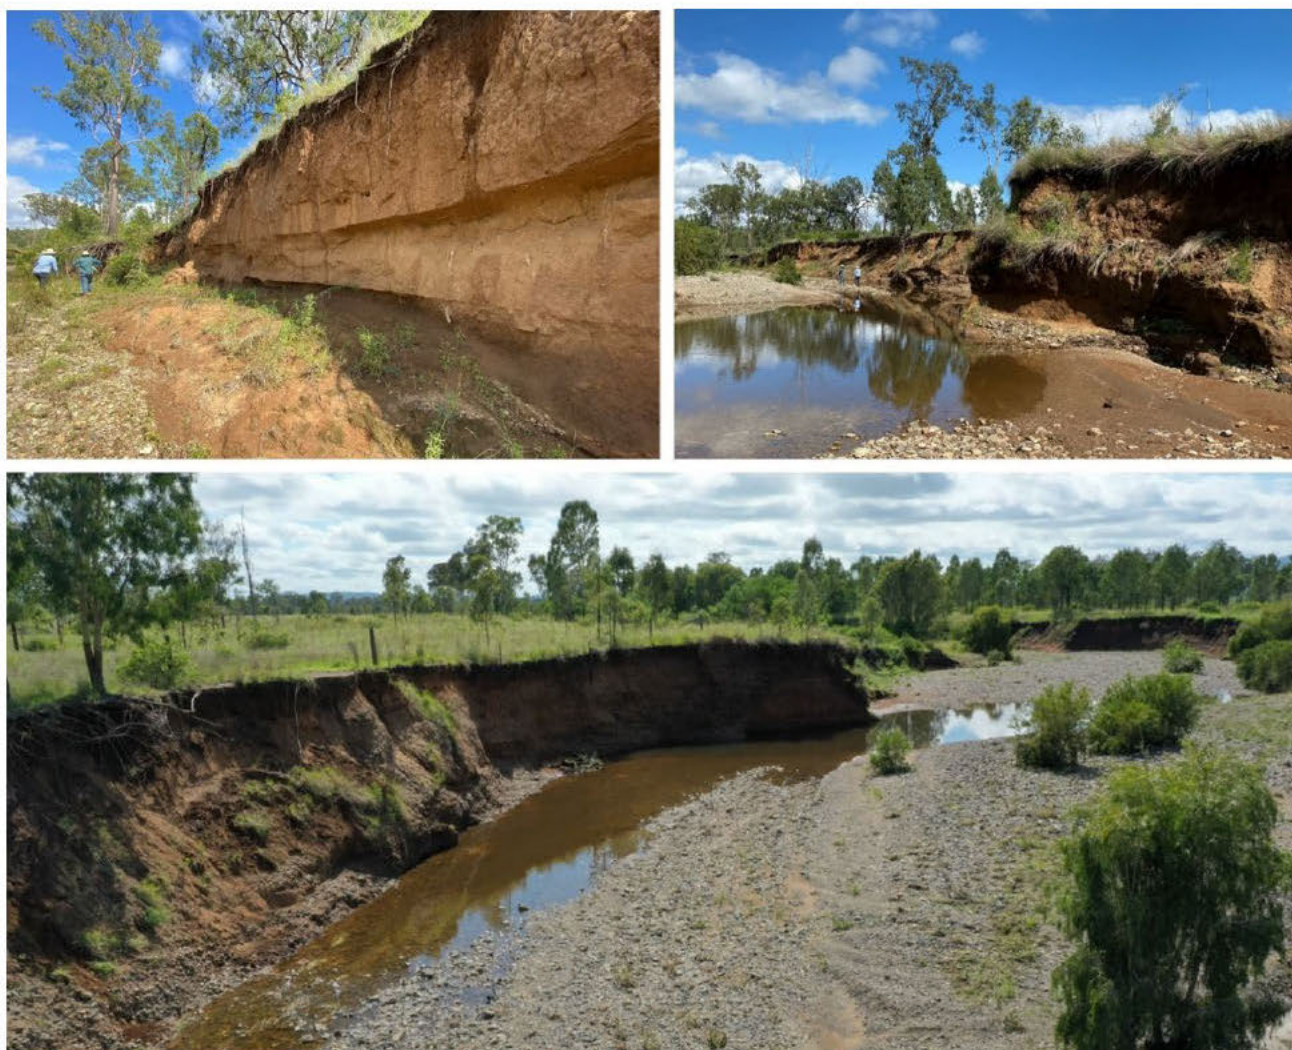
Figure 1.1 The proposed riverbank restoration site includes an eroding section of the left bank approximately 170 m in length and 5 m high, and an eroding section of the right bank immediately downstream approximately 100 m in length and 5 m high. Photos taken December 2021.

Site B is subsequently a river restoration project that will stabilise and revegetate a section of rapidly eroding creek frontage. The proposed works will occur on an eroding section of the left bank approximately 170 m in length and 5 m high and an eroding section of the right bank immediately downstream approximately 100 m in length and 5 m high (Figures 1.2 & 1.3). The site is located on the upper reaches of Langmorn Creek in the lower Fitzroy River catchment within a zone of very high erosion potential where further erosion is almost certain in future floods. Due to the steeply eroded bank slopes, natural regeneration of vegetation capable of resisting future floods is unlikely without works to reshape and stabilise the bank. Without this management intervention the site will continue to erode and continue to contribute a large source of fine sediments into the GBR Lagoon.

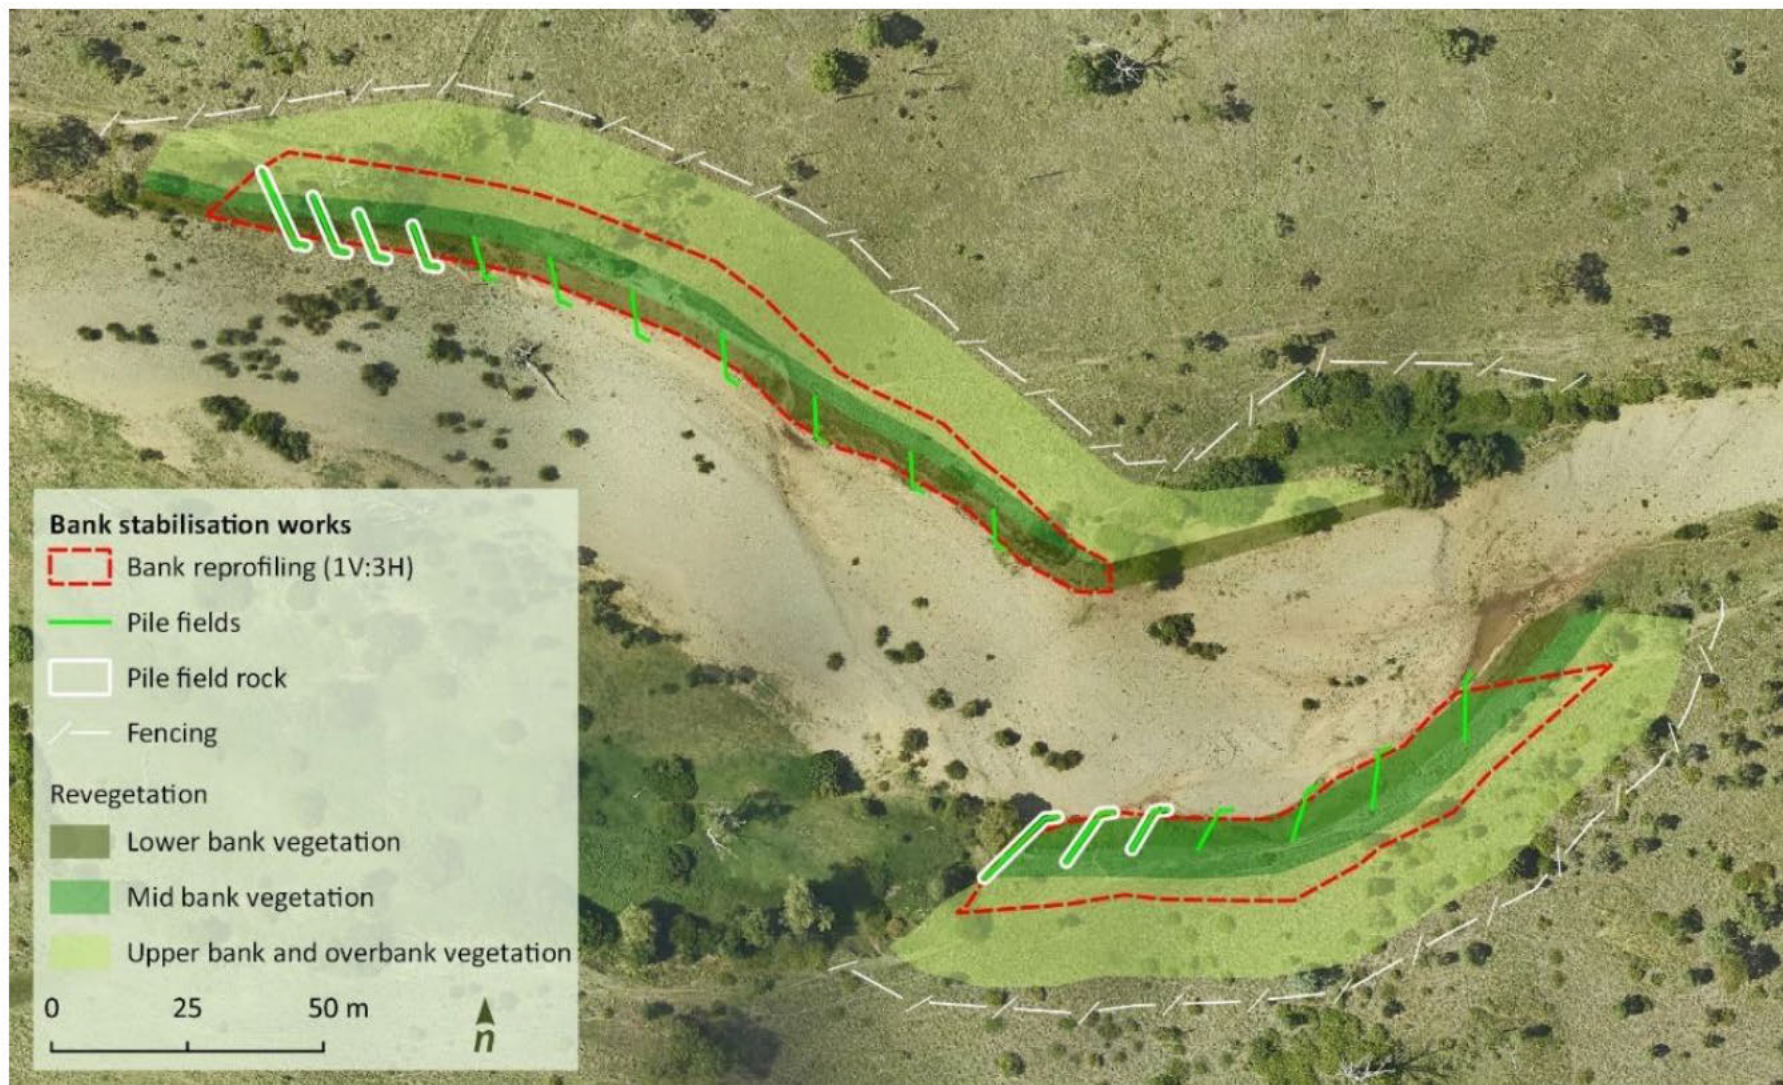
Figure 1.3 The fine sediment project site is located within cleared agricultural land with scattered regrowth. The proposed works will occur on the 300m of actively eroding bank.

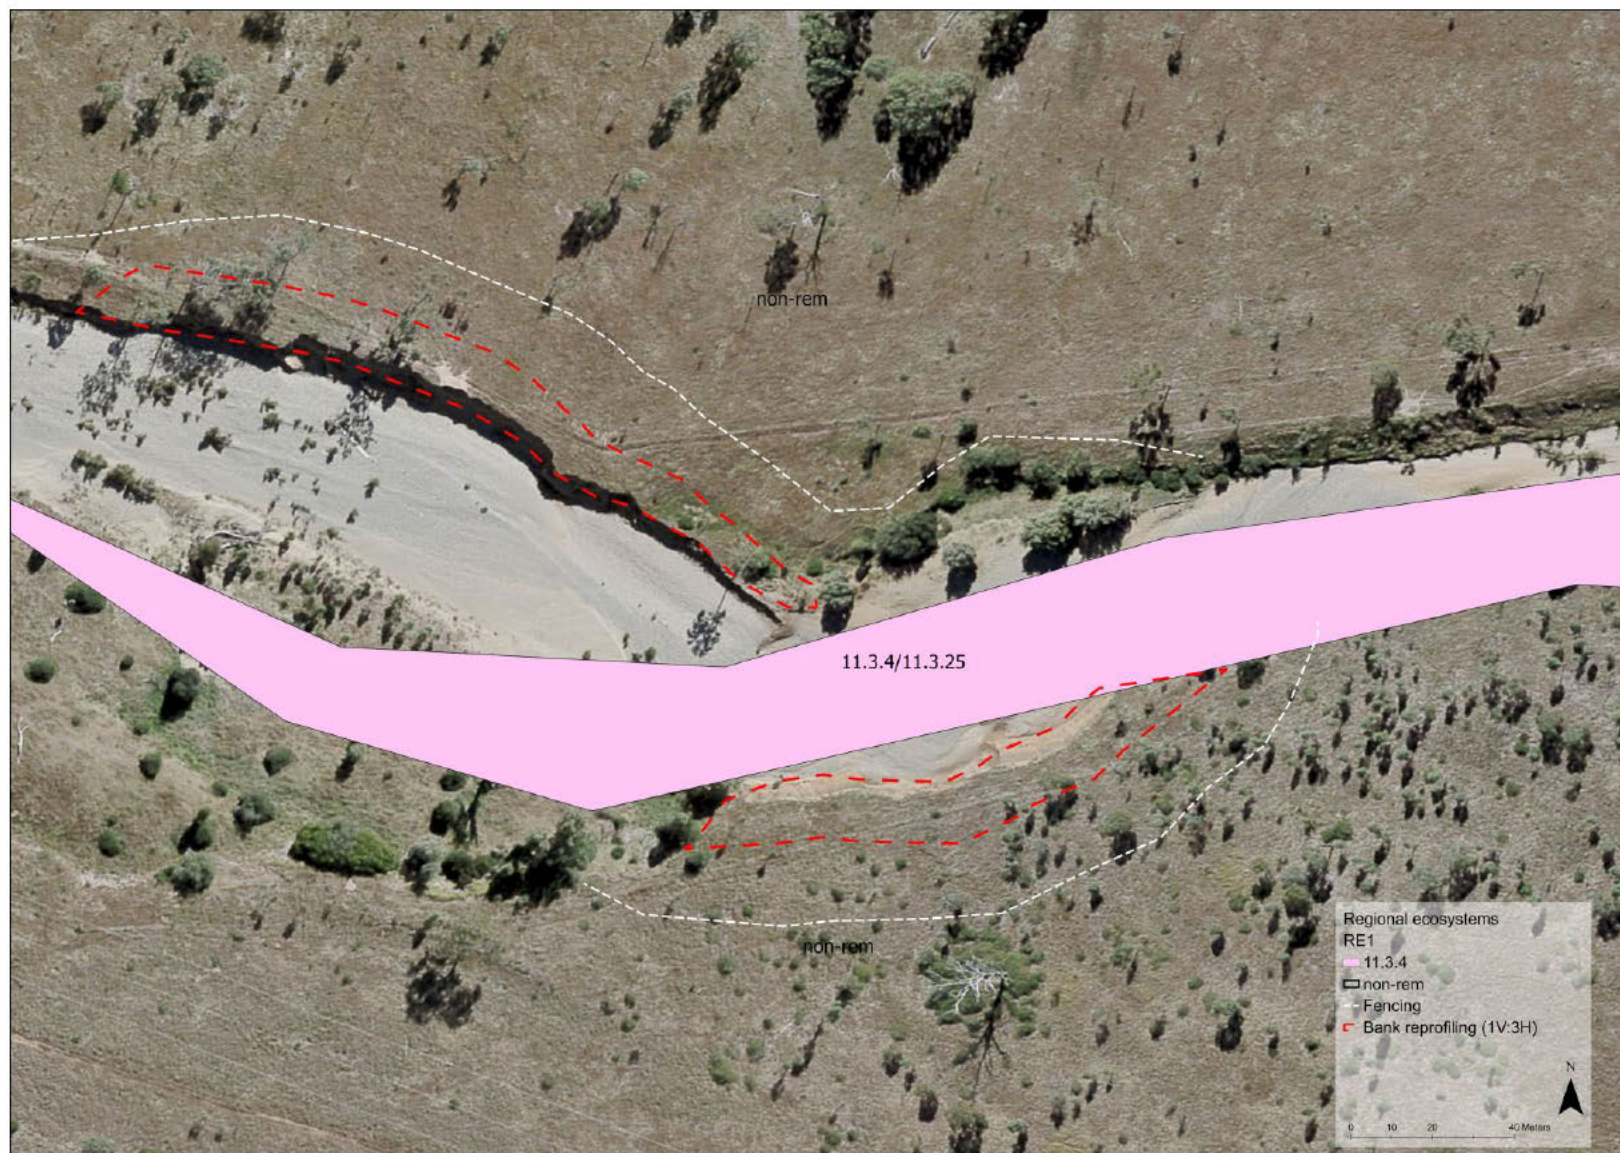
Figure 2.1 Regional ecosystem mapping showing dominant vegetation associations for the Site B study area.

Major vegetation types within the study area were identified with the vegetation management regional ecosystem map – version 11.0 (Downloaded in July 2022). On the construction site side of the river (Figure 2.1) typical of the Fitzroy Basin the dominant vegetation type was non-remnant vegetation, primarily agricultural which made up 90% of this study area. Two Regional ecosystem types were mapped as occurring within the study site 11.3.4 and 11.3.25 fringing the riverbank. Three Threatened Ecological Communities (TEC) were also identified in the EPBC Act Protected Matters report Coolibah Black Box Woodlands, Poplar Box Grassy Woodlands, and Weeping Myall Woodlands (Table 2.1).

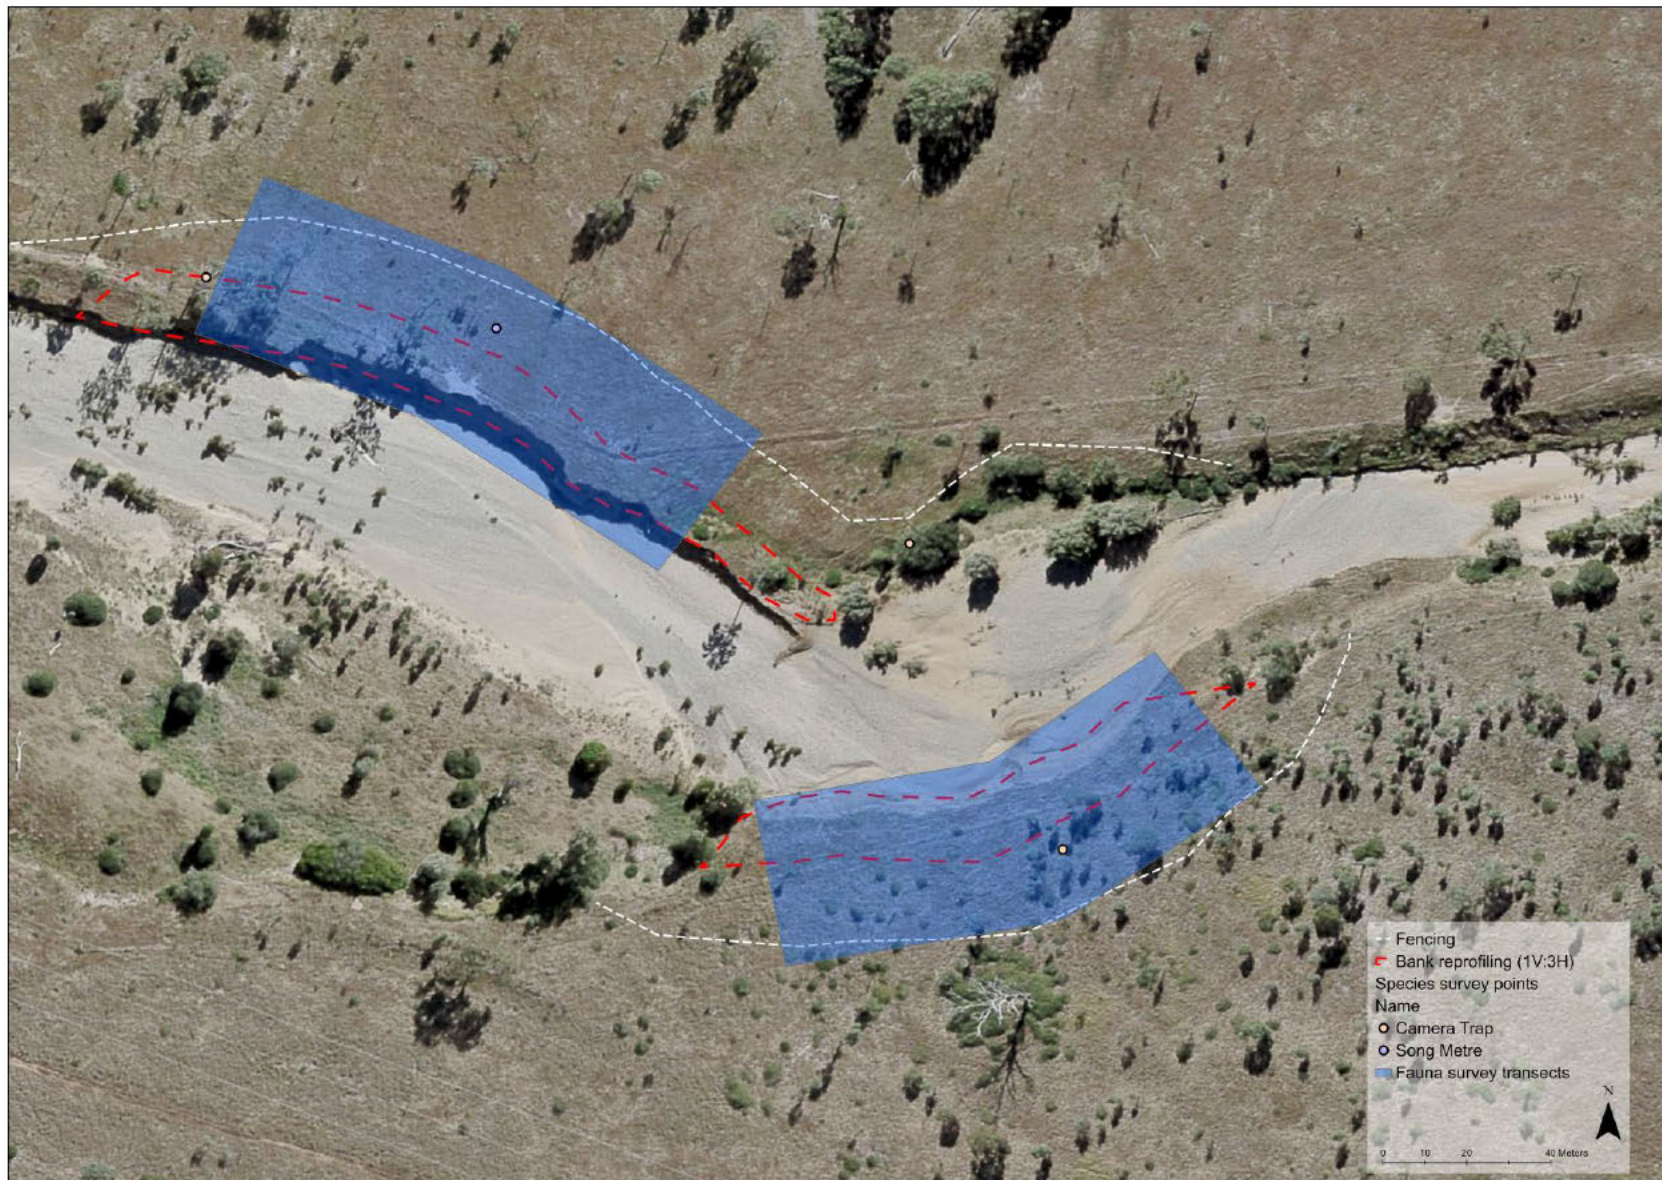
Figure 2.2 Map of Fauna survey transects with placement of camera traps and song meter recording devices.

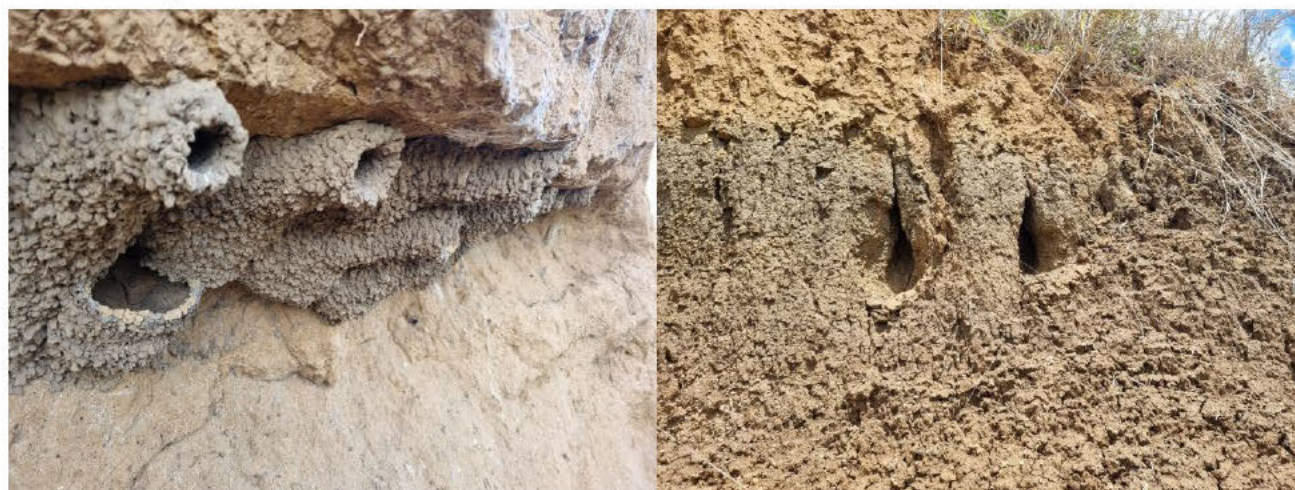
Figure 2.4 Images of Welcome Swallow *Hirundo neoxena* nests taken during fauna surveys completed on the 15th (left) and 29th (right) of September. Mud structures were found on the northern bank with large undercutting bank predicted to collapse with the next high rainfall event. Nest dug into the side of the southern bank were not present at the beginning of fauna surveys but appeared within the week between the fifth and final survey.
